**Flood Control Project Maintenance  
Levee Inspections**

## Maintenance Issue Types Only, Levee Inspection Report By Mile - Spring 2019

### Butte County Department of Public Works

| Waterway | Bank | Unit Miles | Inspection Start/End | Inspector |
|---|---|---|---|---|
| Unit No. 01 Mud Creek | Right | 6.80 | 04/10/2019<br>04/10/2019 | Makar<br>Sokol |

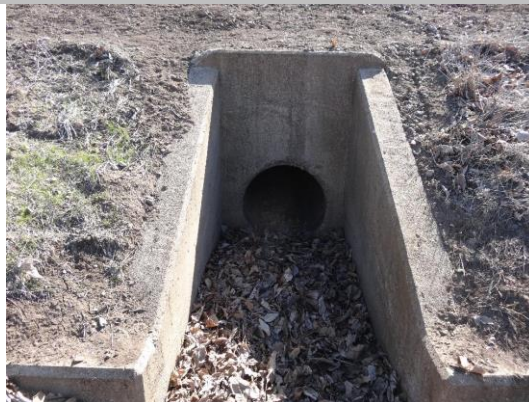
Photo 3 of 3 : UCIP\_SP\_2019\_32044\_58541.jpg

LS view: U typed concrete headwall and CMP on levee slope.

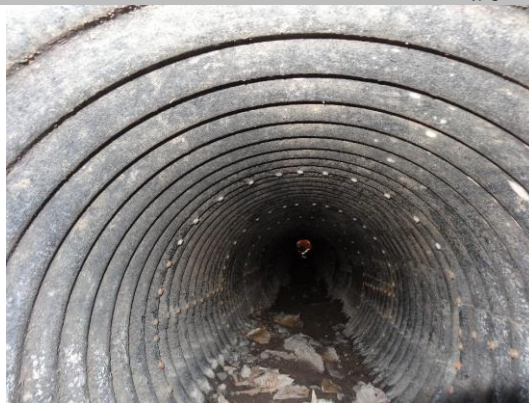
Photo 3 of 3 : UCIP\_SP\_2019\_50142\_55884.jpg

LS view: inside view of CMP on levee slope. Needs cleaning and clearing.

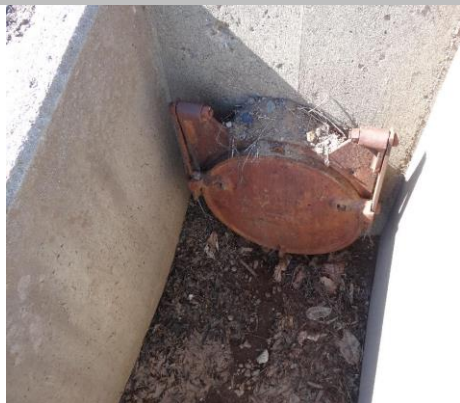
Photo 1 of 2 : UCIP\_SP\_2019\_30294\_55704.jpg

| FS_ID:30294<br>DS_ID:19216<br>EP_NO: N/A<br>Repair Type: Non-Urgent<br>Crossing Status: Found<br>UCIP Comments: Inlet and outlet needs cleaning and clearing of debris.<br>FIELD_STRUCT_DESC: 24-inch corrugated metal gravity drainage pipe through the levee, 8.5 feet below the crown. Flap gate on the waterside (WS) end. Concrete U-shaped headwall on each end. Grouted riprap apron on the landside (LS) end. Grouted riprap spillway on the WS end.<br>[Additional Reference(s): DWR Levee Log, 1992. USACE Sacramento O&M Manual 504, May 1965, (HLM 3.11)].<br>FS Date: 2/20/2014 | | | | | | |

WS view: U type concrete headwall, flapgate on levee slope.

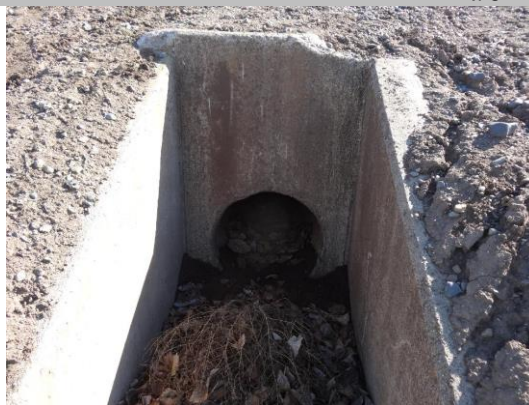
Photo 2 of 3 : UCIP\_SP\_2019\_30310\_55740.jpg

LS view: U type concrete headwall and CMP on levee slope.

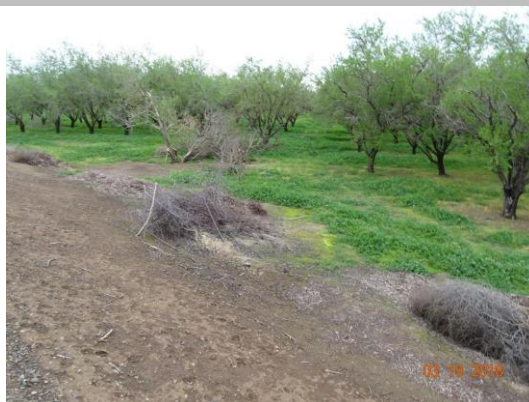
Photo 1 of 1 : SP\_2019\_NA0003\_64\_32\_20190325\_00014.jpg

View of the prunings along the landside toe.

| The prunings should be removed from the landside toe. | | | | | |

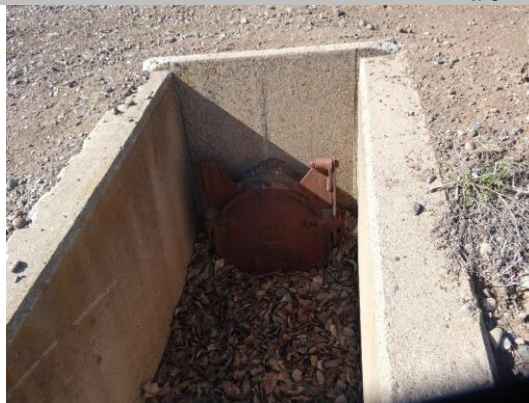
Photo 1 of 2 : UCIP\_SP\_2019\_30311\_55743.jpg

| FS_ID:30311<br>DS_ID:19219<br>EP_NO: N/A<br>Repair Type: Non-Urgent<br>Crossing Status: Found<br>UCIP Comments: Needs cleaning and clearing of debris in both ends of the pipe.<br>FIELD_STRUCT_DESC: 24-inch corrugated metal gravity drainage pipe through the levee, 9 feet below the crown. Flap gate on the waterside (WS) end. Concrete U-shaped headwall on each end. Grouted riprap apron on the landside (LS) end. Grouted riprap spillway on the WS end. [Additional Reference(s): DWR Levee Log, 1992. USACE Sacramento O&M Manual 504, May 1965, (HLM 4.08)].<br>FS Date: 2/20/2014 | | | | | | |

WS view: U type concrete headwall, pipe, and flapgate on levee slope. Vegetation debris blocking outlet.

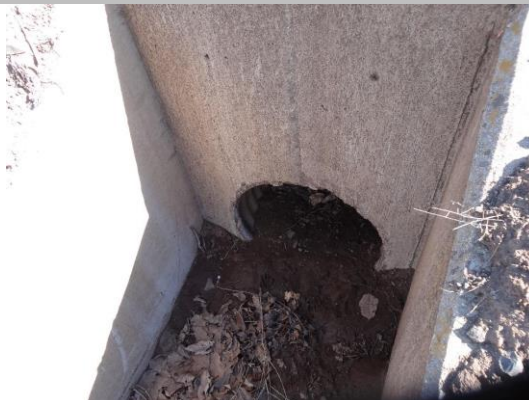
Photo 2 of 2 : UCIP\_SP\_2019\_30311\_55742.jpg

LS view: U type concrete headwall and CMP on levee slope.

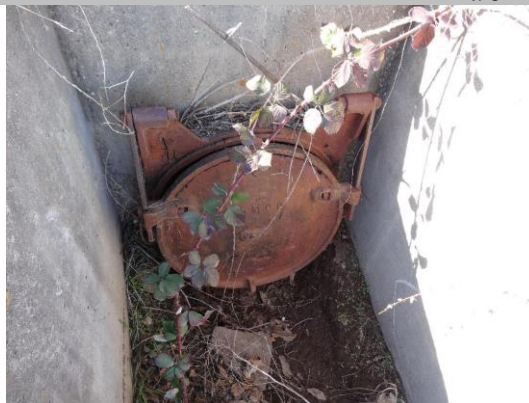
Photo 1 of 2 : UCIP\_SP\_2019\_30312\_55745.jpg

WS view: U type concrete headwall, pipe, and flapgate on levee slope. Vegetation debris blocking outlet.

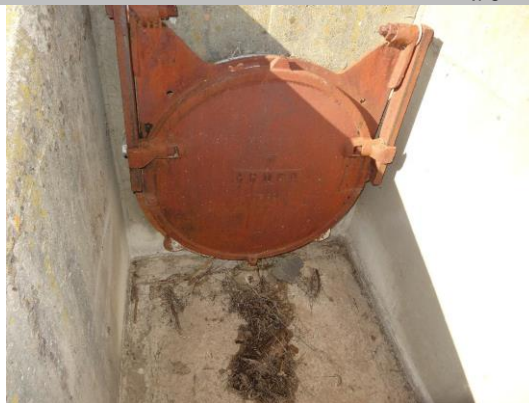
Photo 1 of 3 : UCIP\_SP\_2019\_30327\_55768.jpg

WS view: U type concrete headwall, pipe, and flapgate on levee slope.

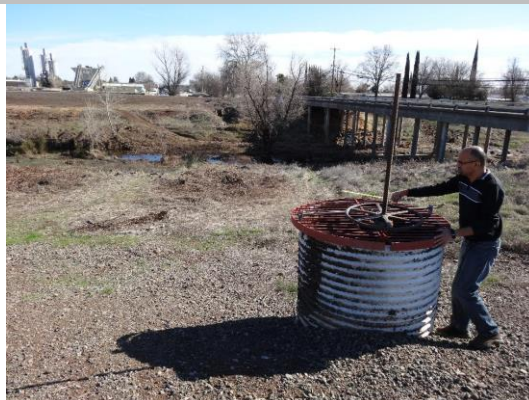
Photo 2 of 3 : UCIP\_SP\_2019\_30327\_55767.jpg

WS view: CM standpipe with slide gate on levee slope.

| FS_ID:30327<br>DS_ID:19222<br>EP_NO: N/A<br>Repair Type: No Action Needed<br>Crossing Status: Found<br>UCIP Comments: Slide gate in CM stadpipe on waterside levee slope.<br>FIELD_STRUCT_DESC: 36-inch corrugated metal gravity drainage pipe through the levee, 17 feet below the crown. Slide gate in a corrugated metal standpipe on the waterside (WS) slope. Flap gate on the WS end. Concrete U-shaped headwall on each end. Grouted riprap apron on the landside (LS) end. Grouted riprap spillway on the WS end.<br>[Additional Reference(s): DWR Levee Log, 1992. USACE Sacramento O&M Manual 504, May 1965, (HLM 5.22)].<br>FS Date: 2/20/2014 | | | | | | |

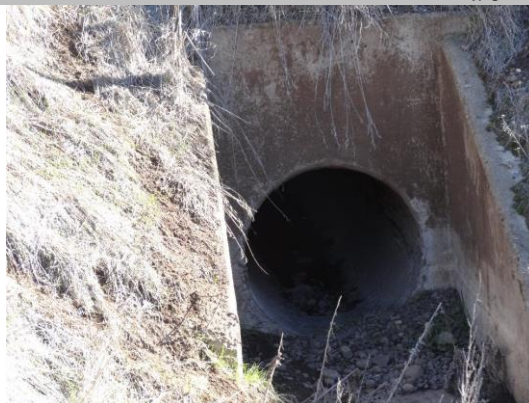
Photo 3 of 3 : UCIP\_SP\_2019\_30327\_55766.jpg

LS view: U type concrete headwall and CMP on levee slope.

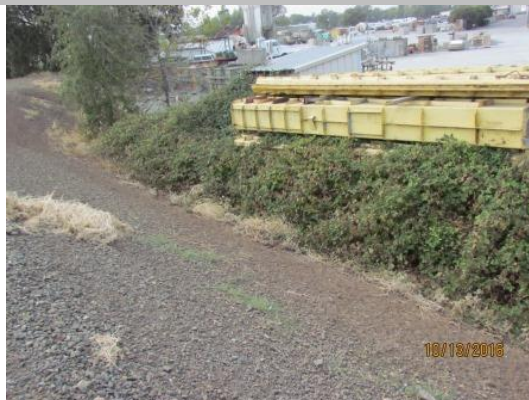
Photo 1 of 1 : SP\_2019\_NA0003\_64\_55\_20190325\_00029.jpg

View of the blackberries blocking visibility and access.

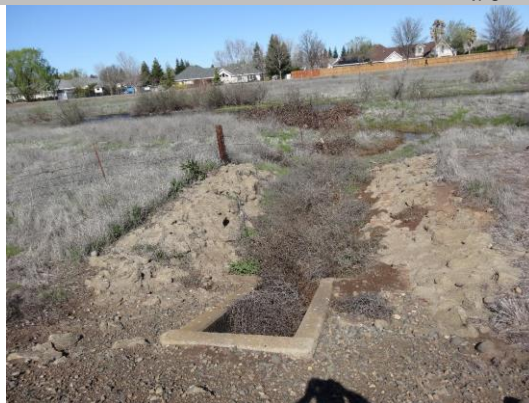
Photo 1 of 3 : UCIP\_SP\_2019\_31667\_57968.jpg

WS view: CMP culvert with U type concrete headwall. Vegetation debris blocking outlet box.

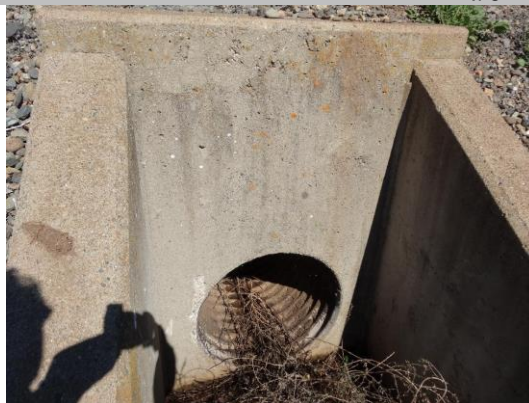
Photo 3 of 3 : UCIP\_SP\_2019\_31667\_57966.jpg

LS view: U type concrete headwall and CMP on levee slope. Vegetation debris on inlet box.

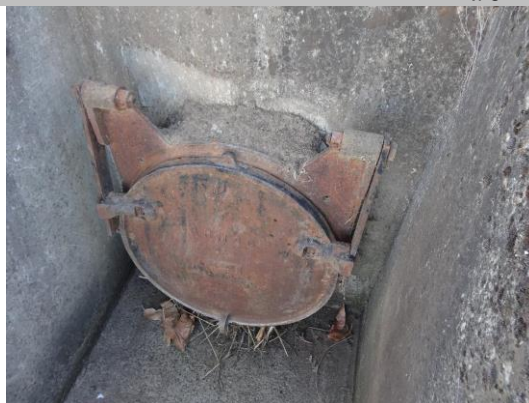
Photo 1 of 3 : UCIP\_SP\_2019\_30403\_55922.jpg

| FS_ID:30403<br>DS_ID:19235<br>EP_NO: N/A<br>Repair Type: Non-Urgent<br>Crossing Status: Found<br>UCIP Comments: Needs cleaning and clearing of debris.<br>FIELD_STRUCT_DESC: 24-inch corrugated metal gravity drainage pipe through the levee, 12.5 feet below the crown. Flap gate on the waterside (WS) end. Concrete U-shaped headwall on each end. Grouted riprap apron on the landside (LS) end. Grouted riprap spillway on the WS end. [Additional Reference(s): DWR Levee Log, 1992. USACE Sacramento O&M Manual 504, May 1965, (HLM 1.34)].<br>FS Date: 2/24/2014 | | | | | | |

WS view: U type concrete headwall, pipe, and flapgate on levee slope.

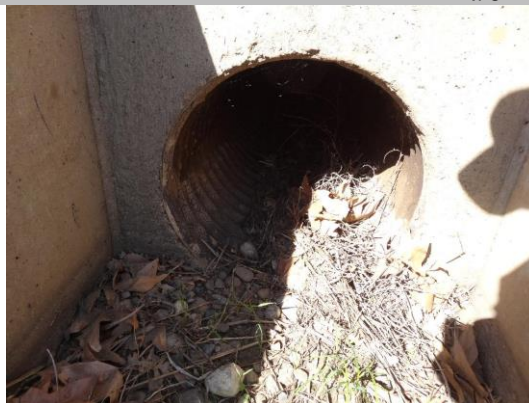
Photo 2 of 3 : UCIP\_SP\_2019\_30403\_55921.jpg

| FS_ID:30403<br>DS_ID:19235<br>EP_NO: N/A<br>Repair Type: Non-Urgent<br>Crossing Status: Found<br>UCIP Comments: Needs cleaning and clearing of debris.<br>FIELD_STRUCT_DESC: 24-inch corrugated metal gravity drainage pipe through the levee, 12.5 feet below the crown. Flap gate on the waterside (WS) end. Concrete U-shaped headwall on each end. Grouted riprap apron on the landside (LS) end. Grouted riprap spillway on the WS end. [Additional Reference(s): DWR Levee Log, 1992. USACE Sacramento O&M Manual 504, May 1965, (HLM 1.34)].<br>FS Date: 2/24/2014 | | | | | | |

LS view: U type concrete headwall and CMP on levee slope. Vegetation debris in inlet pipe.

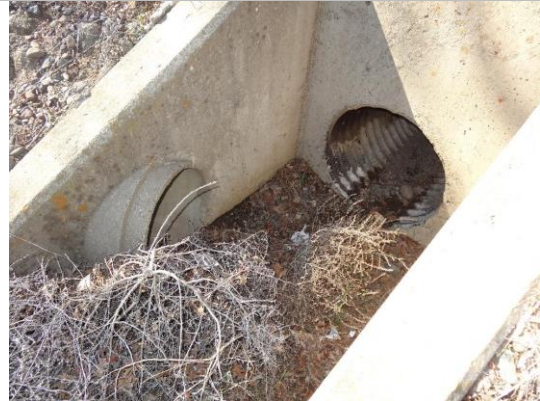
Photo 2 of 2 : UCIP\_SP\_2019\_30743\_56640.jpg

LS view: U type concrete headwall and CMP on levee slope. Vegetation debris and soil in inlet area.

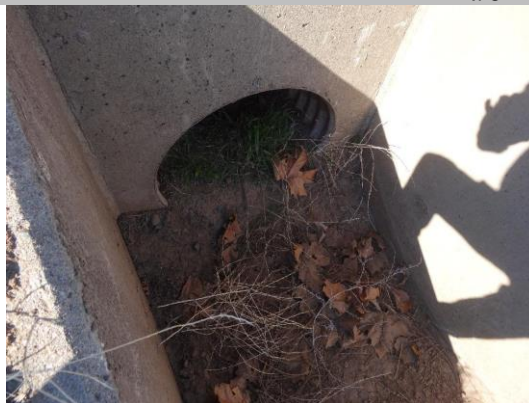
Photo 2 of 3 : UCIP\_SP\_2019\_30763\_56661.jpg

LS view: U type concrete headwall and CMP on levee slope.

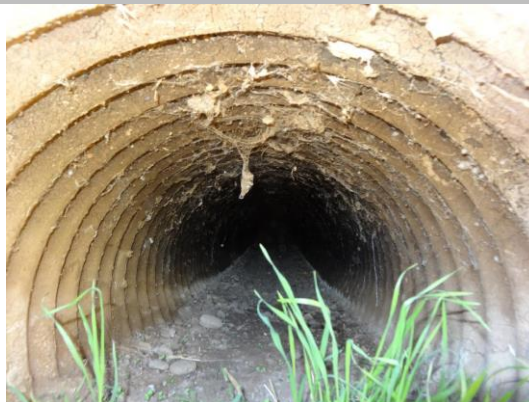
Photo 3 of 3 : UCIP\_SP\_2019\_30763\_56660.jpg

LS view: inside view of CMP on levee slope. Needs cleaning and clearing.

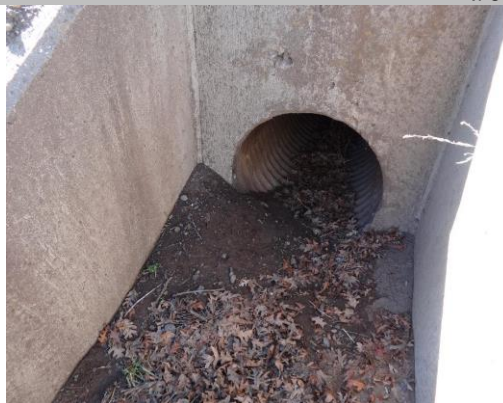
Photo 2 of 3 : UCIP\_SP\_2019\_30783\_56681.jpg

LS view: U type concrete headwall and CMP on levee slope. Debris and soil in inlet box.

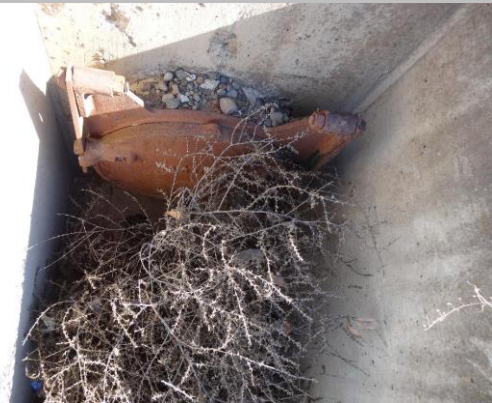
Photo 1 of 3 : UCIP\_SP\_2019\_30803\_56685.jpg

| FS_ID:30803<br>DS_ID:19241<br>EP_NO: N/A<br>Repair Type: Non-Urgent<br>Crossing Status: Found<br>UCIP Comments: Needs cleaning and clearing of debris.<br>FIELD_STRUCT_DESC: 24-inch corrugated metal gravity drainage pipe through the levee, 6.5 feet below the crown. Flap gate on the waterside (WS) end. Concrete U-shaped headwall on each end. Grouted riprap apron on the landside (LS) end. Grouted riprap spillway on the WS end. [Additional Reference(s): DWR Levee Log, 1992. USACE Sacramento O&M Manual 504, May 1965, (HLM 3.64)].<br>FS Date: 2/24/2014 | | | | | |

WS view: U type concrete headwall, pipe, and flapgate on levee slope.  
Vegetation debris and soil blocking outlet.

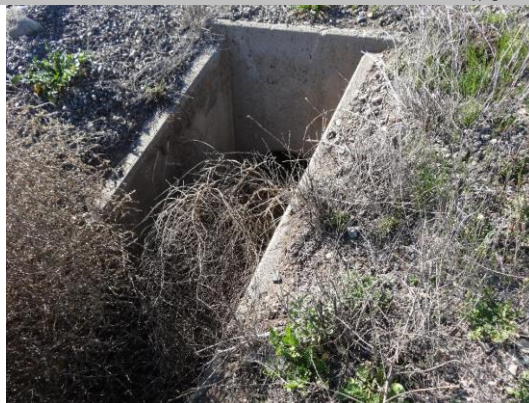
Photo 2 of 3 : UCIP\_SP\_2019\_30803\_56684.jpg

LS view: U type concrete headwall and CMP on levee slope. Vegetation debris and soil blocking inlet.

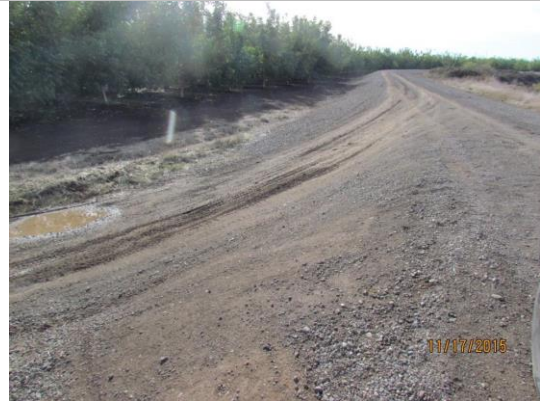
Photo 1 of 1 : SP\_2019\_NA0003\_65\_10\_20190325\_00004.jpg

View of the vehicle erosion along the landside slope.

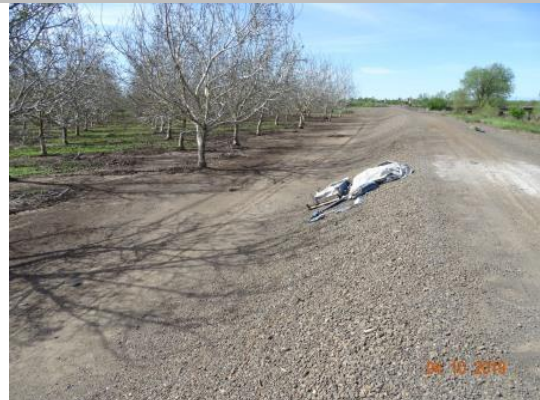
Photo 1 of 1 : SP\_2019\_NA0003\_65\_40\_20190415\_00065.jpg

View of a pile of debris on the landside slope. Spring 2019.

| The pile of debris should be removed from the landside slope. | | | | | |

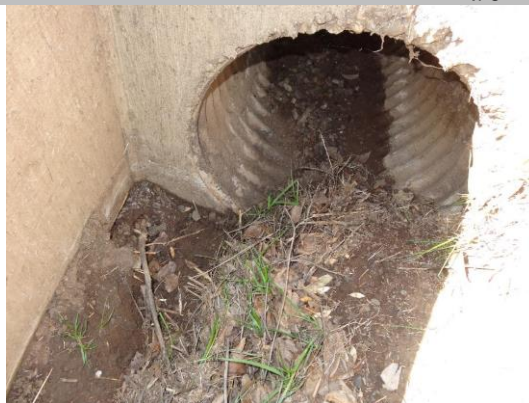
Photo 2 of 3 : UCIP\_SP\_2019\_31028\_56912.jpg

LS view: U type concrete headwall and CMP on levee slope.

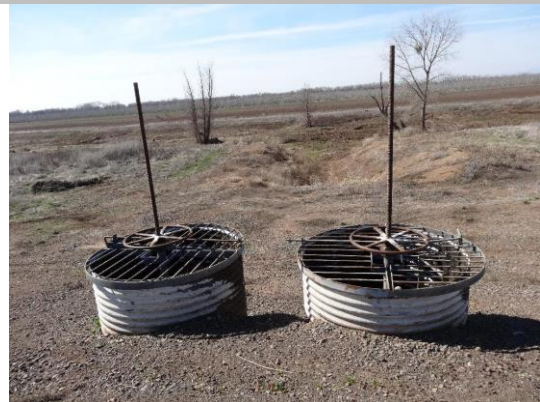
Photo 1 of 3 : UCIP\_SP\_2019\_41376\_56920.jpg

WS view: slide gates in CMP risers on levee slope.

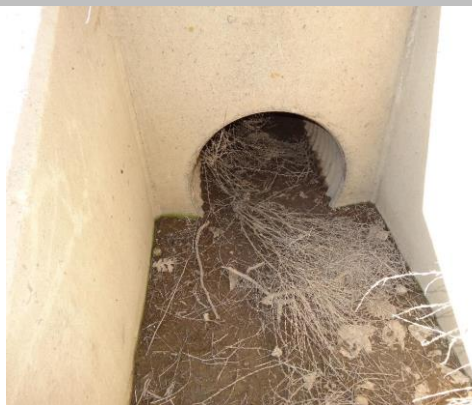
Photo 2 of 3 : UCIP\_SP\_2019\_31103\_57001.jpg

LS view: U type concrete headwall and CMP on levee slope. Soil/mud on inlet box.

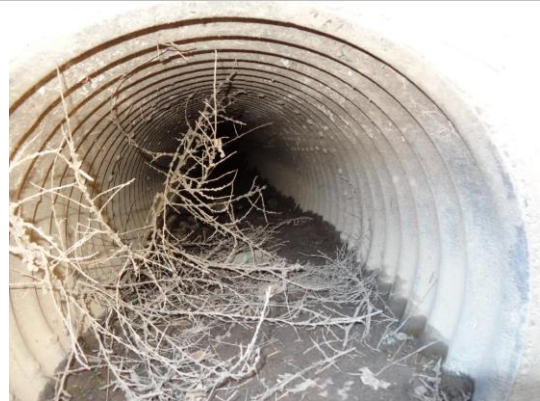
Photo 3 of 3 : UCIP\_SP\_2019\_31103\_57000.jpg

LS view: inside view of CMP on levee slope. Needs cleaning and clearing.

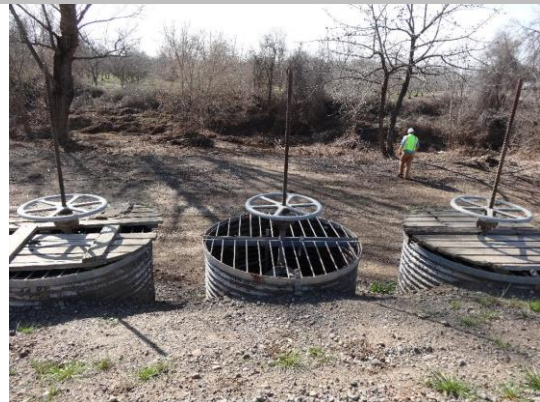
Photo 1 of 3 : UCIP\_SP\_2019\_32085\_58585.jpg

| FS_ID:32085<br>DS_ID:19253<br>EP_NO: N/A<br>Repair Type: Non-Urgent<br>Crossing Status: Found<br>UCIP Comments: Slide gates in CMP risers on waterside shoulder.Needs cleaning and clearing of debris.<br>FIELD_STRUCT_DESC: 1 of 3: 48-inch corrugated metal gravity drainage pipe through the levee, 18 feet below the crown. Flap gate on the waterside (WS) end. Slide gate in a corrugated metal pipe (CMP) riser on the WS shoulder. Concrete U-shaped headwall on each end. Grouted riprap apron on the landside (LS) end. Grouted riprap spillway on the WS end. [Additional Reference(s): DWR Levee Log, 1992. USACE Sacramento O&M Manual 504, May 1965, (HLM 7.46)].<br>FS Date: 2/25/2014 | | | | | |

WS view: slide gates in CMP risers on waterside shoulder.

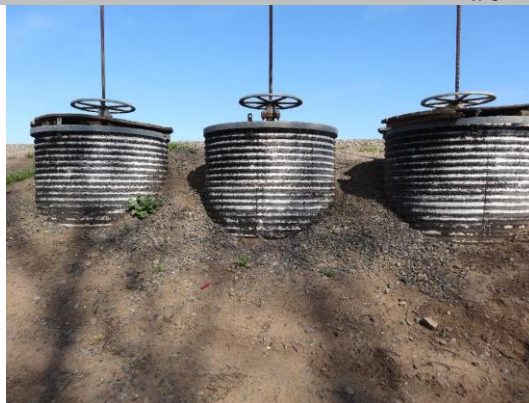
Photo 1 of 3 : UCIP\_SP\_2019\_32087\_58592.jpg

| FS_ID:32087<br>DS_ID:19261<br>EP_NO: N/A<br>Repair Type: Non-Urgent<br>Crossing Status: Found<br>UCIP Comments: Slide gates in CMP risers on waterside shoulder.Needs cleaning and clearing on both pipe ends.<br>FIELD_STRUCT_DESC: 3 of 3: 48-inch corrugated metal gravity drainage pipe through the levee, 18 feet below the crown. Flap gate on the waterside (WS) end. Slide gate in a corrugated metal pipe (CMP) riser on the WS shoulder. Concrete U-shaped headwall on each end. Grouted riprap apron on the landside (LS) end. Grouted riprap spillway on the WS end. [Additional Reference(s): DWR Levee Log, 1992. USACE Sacramento O&M Manual 504, May 1965, (HLM 7.46)].<br>FS Date: 2/25/2014 | | | | | |

WS view: slide gates in CMP risers on waterside shoulder.

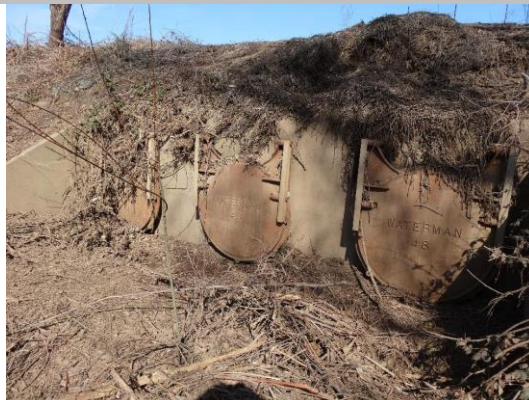
Photo 2 of 3 : UCIP\_SP\_2019\_32087\_58591.jpg

WS view: U type concrete headwall, pipes, and flapgates on levee slope.  
Soil/mud on outlet box. Vegetation debris on outlet box

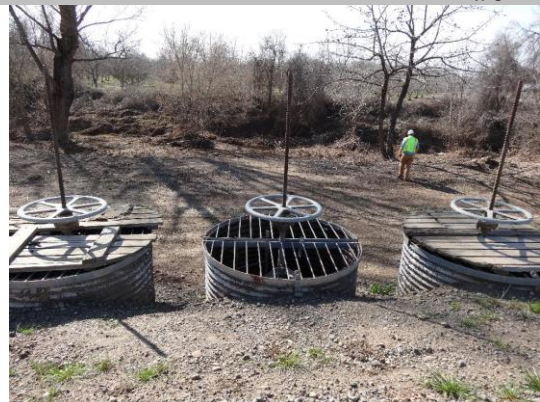
Photo 1 of 3 : UCIP\_SP\_2019\_32086\_58589.jpg

WS view: slide gates in CMP risers on waterside shoulder.

| FS_ID:32086<br>DS_ID:19260<br>EP_NO: N/A<br>Repair Type: Non-Urgent<br>Crossing Status: Found<br>UCIP Comments: Slide gates in CMP risers on waterside shoulder.Needs cleaning and clearing of debris.<br>FIELD_STRUCT_DESC: 2 of 3: 48-inch corrugated metal gravity drainage pipe through the levee, 18 feet below the crown. Flap gate on the waterside (WS) end. Slide gate in a corrugated metal pipe (CMP) riser on the WS shoulder. Concrete U-shaped headwall on each end. Grouted riprap apron on the landside (LS) end. Grouted riprap spillway on the WS end. [Additional Reference(s): DWR Levee Log, 1992. USACE Sacramento O&M Manual 504, May 1965, (HLM 7.46)].<br>FS Date: 2/25/2014 | | | | | | |

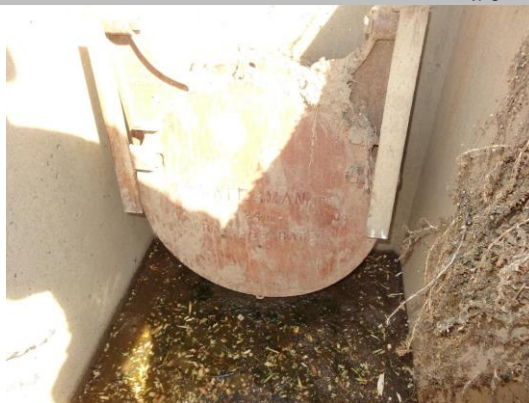
Photo 1 of 2 : UCIP\_SP\_2019\_31129\_57036.jpg

| FS_ID:31129<br>DS_ID:19254<br>EP_NO: N/A<br>Repair Type: Non-Urgent<br>Crossing Status: Found<br>UCIP Comments: Debris in inlet pipe, needs cleaning and clearing.<br>FIELD_STRUCT_DESC: 24-inch corrugated metal gravity drainage pipe through the levee, 18 feet below the crown. Flap gate on the waterside (WS) end. Concrete U-shaped headwall on each end. Grouted riprap apron on the landside (LS) end. Grouted riprap spillway on the WS end.<br>[Additional Reference(s): DWR Levee Log, 1992. USACE Sacramento O&M Manual 504, May 1965, (HLM 8.09)].<br>FS Date: 2/25/2014 | | | | | | |

WS view: U type concrete headwall, pipe, and flapgate on levee slope.  
Soil/mud on outlet box.

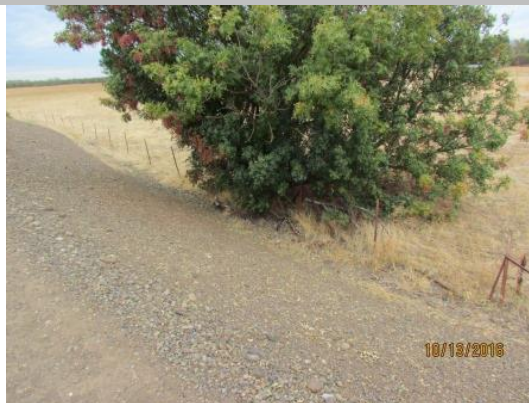
Photo 1 of 1 : SP\_2019\_NA0003\_67\_15\_20190325\_00004.jpg

View of the overgrown tree along the landside slope.

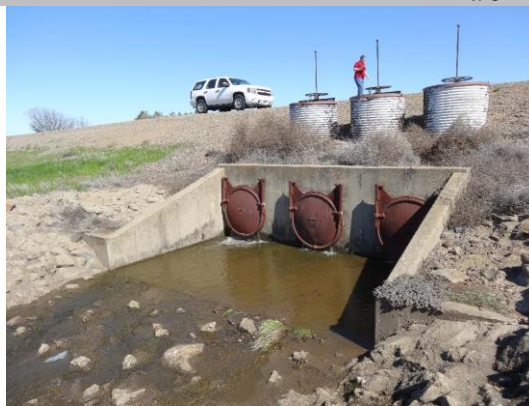
Photo 1 of 2 : UCIP\_SP\_2019\_32104\_58606.jpg

| FS_ID:32104<br>DS_ID:19278<br>EP_NO: N/A<br>Repair Type: No Action Needed<br>Crossing Status: Found<br>UCIP Comments: Slide gate in CMP riser on waterside.The culvert was working during the field visit.<br>FIELD_STRUCT_DESC: 1 of 3: 48-inch corrugated metal gravity drainage pipe through the levee, 11.7 feet below the crown. Slide gate in a riser well on the waterside (WS) slope. Concrete U-shaped headwall on each end. Flap gate on the WS end. Grouted riprap outlet channel on the WS. [Additional Reference(s): DWR Levee Log, 1992. USACE Sacramento O&M Manual 504, May 1965, (HLM 0.39)].<br>FS Date: 3/11/2014 | | | | | |

WS view: U type concrete headwall and three CMPs with slide gates on levee slope. Grouted riprap spillway.

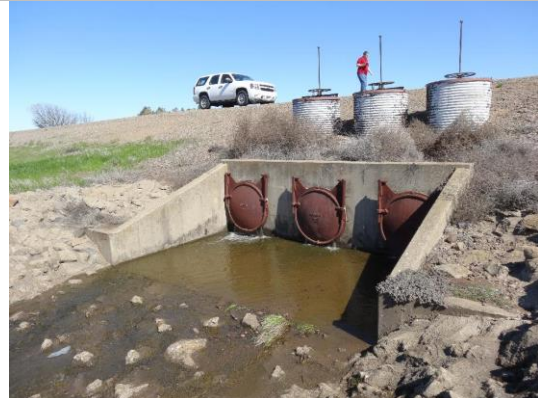
Photo 1 of 2 : UCIP\_SP\_2019\_32105\_58608.jpg

| FS_ID:32105<br>DS_ID:19277<br>EP_NO: N/A<br>Repair Type: No Action Needed<br>Crossing Status: Found<br>UCIP Comments: Slide gate in CMP riser on waterside.The culvert was working during the field visit.<br>FIELD_STRUCT_DESC: 2 of 3: 48-inch corrugated metal gravity drainage pipe through the levee, 11.7 feet below the crown. Slide gate in a riser well on the waterside (WS) slope. Concrete U-shaped headwall on each end. Flap gate on the WS end. Grouted riprap outlet channel on the WS. [Additional Reference(s): DWR Levee Log, 1992. USACE Sacramento O&M Manual 504, May 1965, (HLM 0.39)].<br>FS Date: 3/11/2014 | | | | | |

WS view: U type concrete headwall and three CMPs with slide gates on levee slope. Grouted riprap spillway.

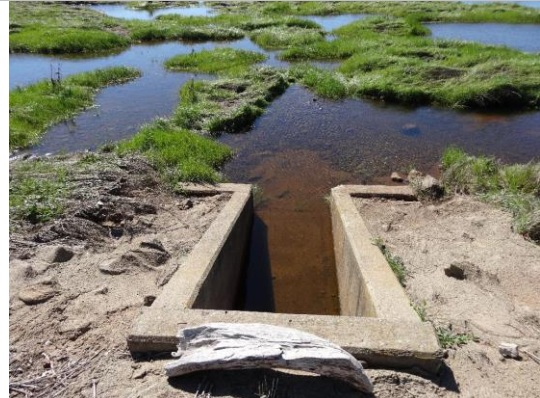
Photo 1 of 3 : UCIP\_SP\_2019\_32107\_58613.jpg

WS view: U type concrete headwall and grouted riprap on levee slope.

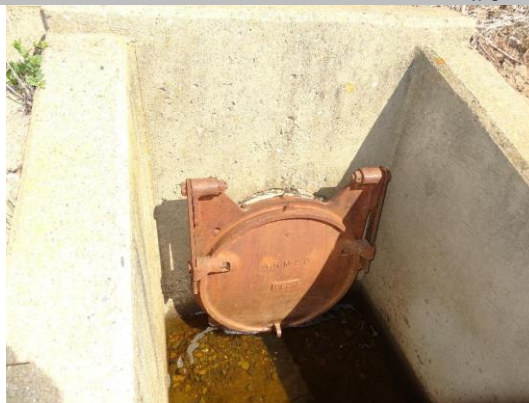
Photo 2 of 3 : UCIP\_SP\_2019\_32107\_58612.jpg

WS view: U type concrete headwall, flapgate, and CMP on levee slope.

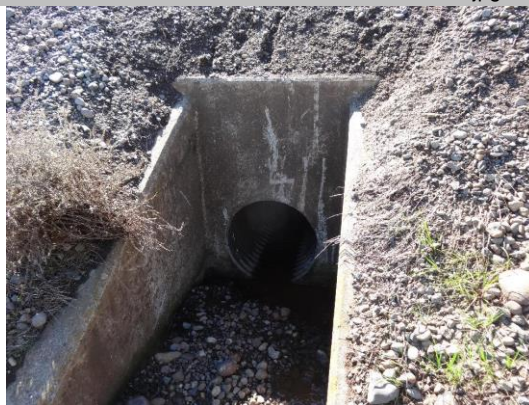
Photo 3 of 3 : UCIP\_SP\_2019\_32107\_58611.jpg

LS view: U type concrete headwall and CMP on levee slope.

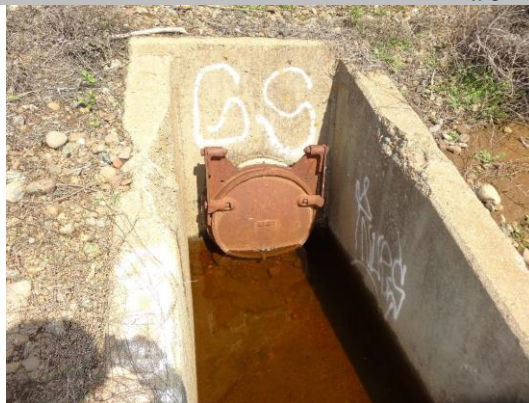
Photo 1 of 2 : UCIP\_SP\_2019\_31899\_58187.jpg

WS view: U type concrete headwall, flapgate, and CMP on levee slope. Looks clean and clear.

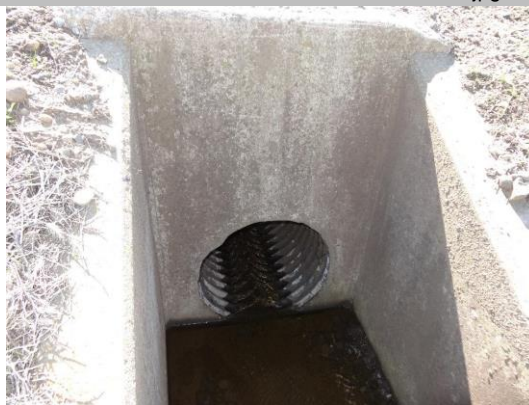
Photo 2 of 2 : UCIP\_SP\_2019\_31899\_58186.jpg

LS view: U type concrete headwall and CMP on levee slope. Looks clean and clear.

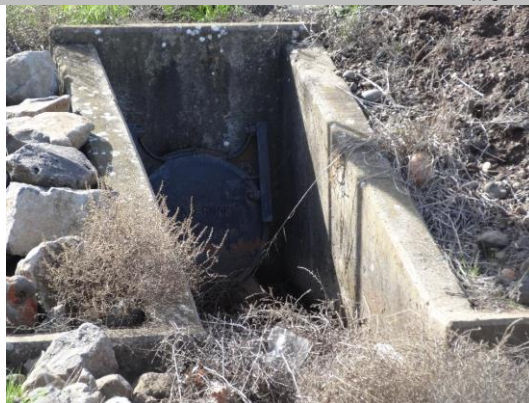
Photo 1 of 3 : UCIP\_SP\_2019\_32124\_58625.jpg

| FS_ID:32124<br>DS_ID:19267<br>EP_NO: N/A<br>Repair Type: Non-Urgent<br>Crossing Status: Found<br>UCIP Comments: Pipe is about 4 feet below the crown. Needs cleaning and clearing the culvert.<br>FIELD_STRUCT_DESC: 24-inch corrugated metal gravity drainage pipe through the levee, 6 feet below the crown. Flap gate on the waterside (WS) end. Concrete U-shaped headwall on each end. [Additional Reference(s): DWR Levee Log, 1992. USACE Sacramento O&M Manual 504, May 1965, (HLM 2.23)].<br>FS Date: 3/7/2014 | | | | | | |

WS view: concrete headwall, pipe, and flapgate on levee slope.  
Vegetation and mud on outlet box.

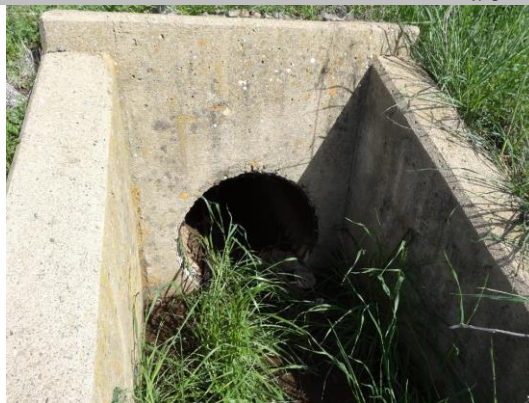
Photo 3 of 3 : UCIP\_SP\_2019\_32124\_58627.jpg

| FS_ID:32124<br>DS_ID:19267<br>EP_NO: N/A<br>Repair Type: Non-Urgent<br>Crossing Status: Found<br>UCIP Comments: Pipe is about 4 feet below the crown. Needs cleaning and clearing the culvert.<br>FIELD_STRUCT_DESC: 24-inch corrugated metal gravity drainage pipe through the levee, 6 feet below the crown. Flap gate on the waterside (WS) end. Concrete U-shaped headwall on each end. [Additional Reference(s): DWR Levee Log, 1992. USACE Sacramento O&M Manual 504, May 1965, (HLM 2.23)].<br>FS Date: 3/7/2014 | | | | | | |

LS view: inside view of CMP on levee slope. Needs cleaning and clearing.

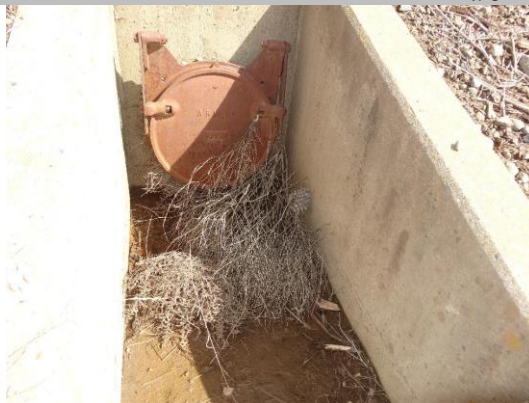
Photo 1 of 3 : UCIP\_SP\_2019\_31901\_58194.jpg

| FS_ID:31901<br>DS_ID:19269<br>EP_NO: N/A<br>Repair Type: Non-Urgent<br>Crossing Status: Found<br>UCIP Comments: Needs cleaning and clearing the culvert.<br>FIELD_STRUCT_DESC: 24-inch corrugated metal gravity drainage pipe through the levee, 11 feet below the crown. Flap gate on the waterside (WS) end. Concrete U-shaped headwall on each end. Grouted riprap apron on the landside (LS) end. Grouted riprap spillway on the WS end. [Additional Reference(s): DWR Levee Log, 1992. USACE Sacramento O&M Manual 504, May 1965, (HLM 3.16)].<br>FS Date: 3/7/2014 | | | | | |

WS view: U type concrete headwall, flapgate, and CMP on levee slope.  
Needs cleaning and clearing.

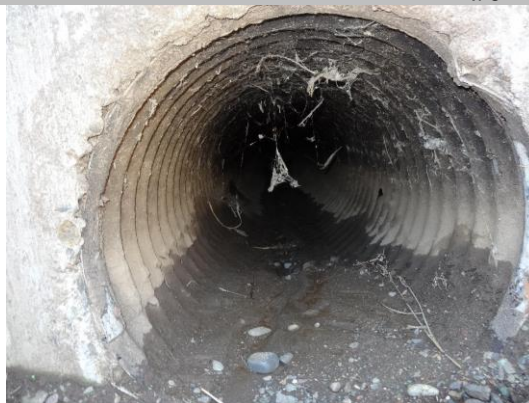
Photo 3 of 3 : UCIP\_SP\_2019\_31901\_58195.jpg

| FS_ID:31901<br>DS_ID:19269<br>EP_NO: N/A<br>Repair Type: Non-Urgent<br>Crossing Status: Found<br>UCIP Comments: Needs cleaning and clearing the culvert.<br>FIELD_STRUCT_DESC: 24-inch corrugated metal gravity drainage pipe through the levee, 11 feet below the crown. Flap gate on the waterside (WS) end. Concrete U-shaped headwall on each end. Grouted riprap apron on the landside (LS) end. Grouted riprap spillway on the WS end. [Additional Reference(s): DWR Levee Log, 1992. USACE Sacramento O&M Manual 504, May 1965, (HLM 3.16)].<br>FS Date: 3/7/2014 | | | | | | |

LS view: inside view of CMP on levee slope. Needs cleaning and clearing.

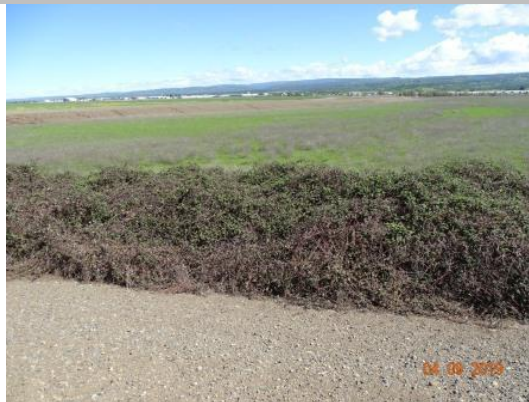
Photo 1 of 1 : SP\_2019\_NA0003\_67\_22\_20190415\_00038.jpg

View of the wild growth at the landside toe. Spring 2019.

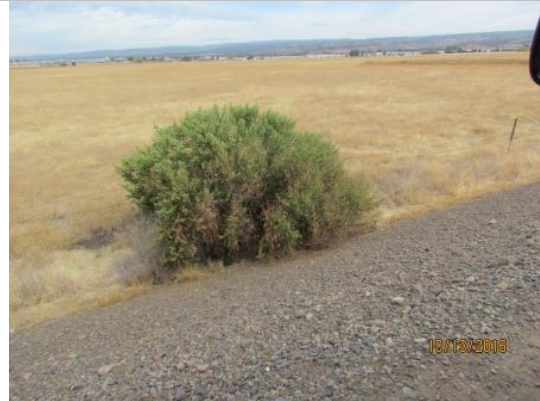
Photo 1 of 1 : SP\_2019\_NA0003\_67\_14\_20190325\_00003.jpg

View of a bush along the landside toe.

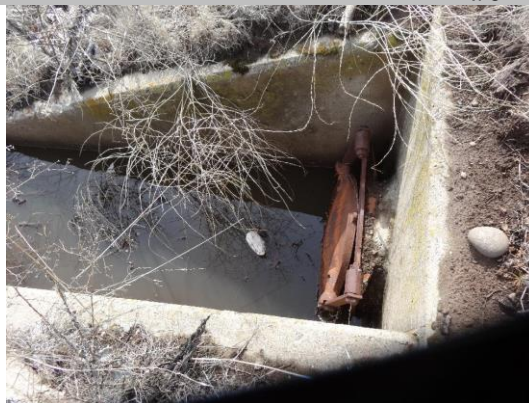
Photo 1 of 2 : UCIP\_SP\_2019\_32125\_58629.jpg

| FS_ID:32125<br>DS_ID:19275<br>EP_NO: N/A<br>Repair Type: Non-Urgent<br>Crossing Status: Found<br>UCIP Comments: The culvert was working during the field visit.Needs cleaning and clearing on both ends of the pipe.<br>FIELD_STRUCT_DESC: 24-inch corrugated metal gravity drainage pipe through the levee, 7.5 feet below the crown. Flap gate on the waterside (WS) end. Concrete U-shaped headwall on each end. Grouted riprap apron on the landside (LS) end. Grouted riprap spillway on the WS end. [Additional Reference(s): DWR Levee Log, 1992. USACE Sacramento O&M Manual 504, May 1965, (HLM 3.76)].<br>FS Date: 3/4/2014 | | | | | |

WS view: U type concrete headwall, pipe, and flapgate on levee slope. Soil/mud on outlet box. Vegetation debris blocking outlet box.

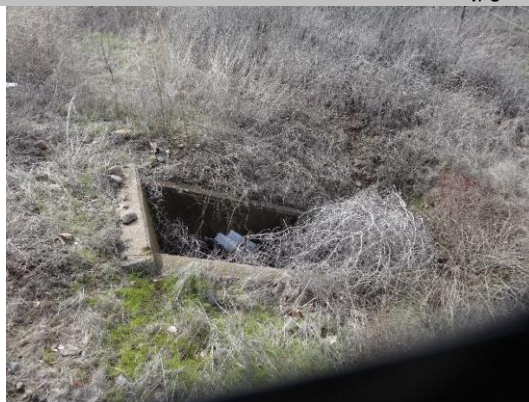
Photo 2 of 2 : UCIP\_SP\_2019\_32125\_58628.jpg

LS view: U type concrete headwall and pipe on levee slope. Soil/mud on inlet box. Vegetation debris blocking inlet box.

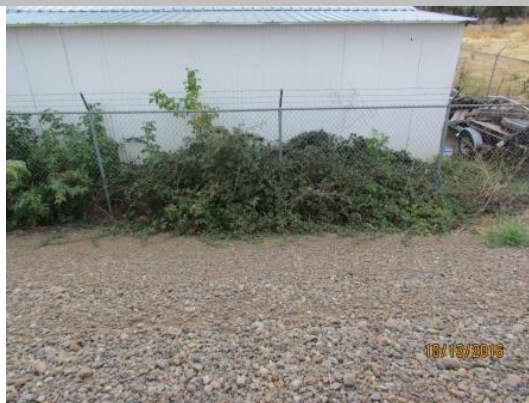
Photo 1 of 1 : SP\_2019\_NA0003\_68\_20\_20190325\_00005.jpg

View of the vegetation along the landside toe.

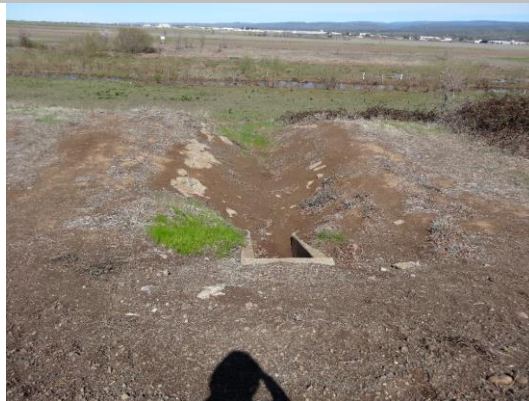
Photo 1 of 3 : UCIP\_SP\_2019\_32026\_58520.jpg

WS view: concrete headwall and grouted riprap spillway on levee slope.

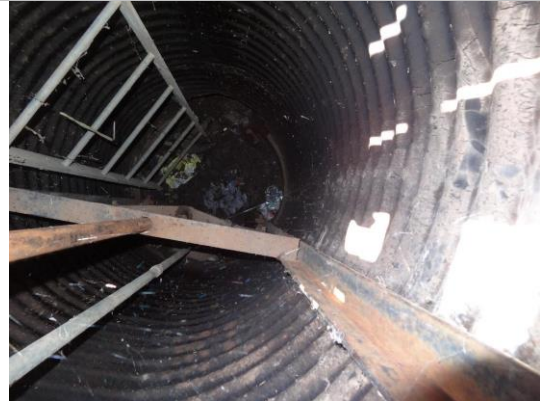
Photo 2 of 3 : UCIP\_SP\_2019\_32025\_58511.jpg

| FS_ID:32025<br>DS_ID:19280<br>EP_NO: N/A<br>Repair Type: Non-Urgent<br>Crossing Status: Found<br>UCIP Comments: Slide gate in a CMP riser. Vegetation debris and mud on inlet box.Needs cleaning and clearing the culvert.<br>FIELD_STRUCT_DESC: 24-inch corrugated metal gravity drainage pipe through the levee and under the channel, 9.5 feet below the crown.<br>Slide gate in a corrugated metal pipe (CMP) riser on the waterside (WS) slope. Concrete U-shaped headwall on the landside (LS) end.<br>[Additional Reference(s): DWR Levee Log, 1992. USACE Sacramento O&M Manual 504, May 1965, (HLM 0.34)].<br>FS Date: 3/7/2014 | | | | | |

WS view: inside view of slide gate in CMP riser on waterside shoulder.  
Debris trapped in the riser.

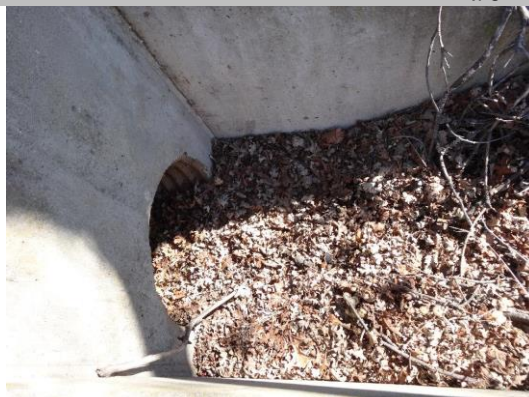
Photo 2 of 2 : UCIP\_SP\_2019\_32143\_58640.jpg

LS view: U type concrete headwall and CMP on levee slope. Vegetation and mud on inlet box.

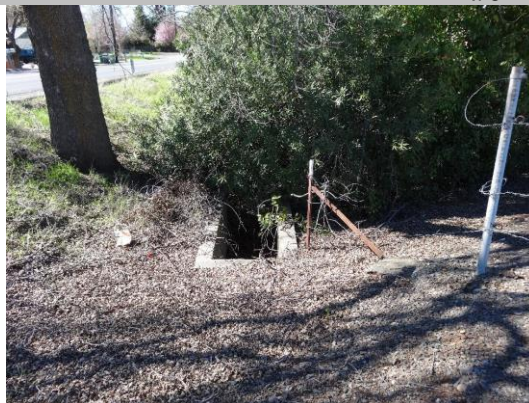
Photo 1 of 3 : UCIP\_SP\_2019\_32144\_58644.jpg

| FS_ID:32144<br>DS_ID:19288<br>EP_NO: N/A<br>Repair Type: Non-Urgent<br>Crossing Status: Found<br>UCIP Comments: Slide gate in CMP riser on waterside. No access to CMP riser.Needs cleaning and clearing the culvert.<br>FIELD_STRUCT_DESC: 24-inch corrugated metal gravity drainage pipe through the levee and under the channel, 9.5 feet below the crown. Slide gate in a pipe riser on the waterside (WS) slope. Concrete U-shaped headwall on the landside (LS) end. [Additional Reference(s): DWR Levee Log, 1992. USACE Sacramento O&M Manual 504, May 1965, (HLM 0.98)].<br>FS Date: 3/7/2014 | | | | | |

LS view: U type concrete headwall of CMP culvert on levee slope. Vegetation debris and mud on inlet box.

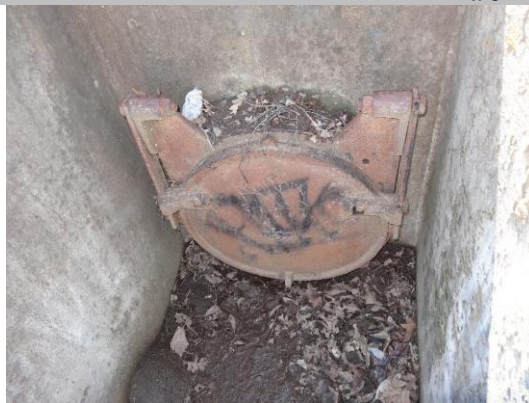
Photo 1 of 3 : UCIP\_SP\_2019\_31963\_58384.jpg

| FS_ID:31963<br>DS_ID:19289<br>EP_NO: N/A<br>Repair Type: Non-Urgent<br>Crossing Status: Found<br>UCIP Comments: Needs cleaning and clearing the culvert.<br>FIELD_STRUCT_DESC: 24-inch corrugated metal gravity drainage pipe through the levee, 11 feet below the crown. Flap gate on the waterside (WS) end. Concrete U-shaped headwall on each end. Grouted riprap apron on the landside (LS) end. Grouted riprap spillway on the WS end. [Additional Reference(s): DWR Levee Log, 1992. USACE Sacramento O&M Manual 504, May 1965, (HLM 1.15)].<br>FS Date: 3/7/2014 | | | | | | |

WS view: U type concrete headwall and CMP on levee slope. Vegetation debris and mud on outlet box. Needs cleaning and clearing.

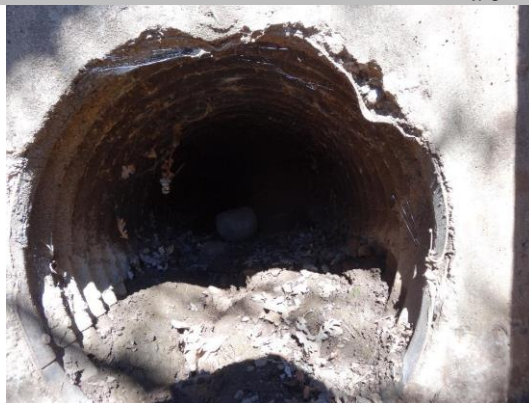
Photo 3 of 3 : UCIP\_SP\_2019\_31963\_58385.jpg

| FS_ID:31963<br>DS_ID:19289<br>EP_NO: N/A<br>Repair Type: Non-Urgent<br>Crossing Status: Found<br>UCIP Comments: Needs cleaning and clearing the culvert.<br>FIELD_STRUCT_DESC: 24-inch corrugated metal gravity drainage pipe through the levee, 11 feet below the crown. Flap gate on the waterside (WS) end. Concrete U-shaped headwall on each end. Grouted riprap apron on the landside (LS) end. Grouted riprap spillway on the WS end. [Additional Reference(s): DWR Levee Log, 1992. USACE Sacramento O&M Manual 504, May 1965, (HLM 1.15)].<br>FS Date: 3/7/2014 | | | | | | |

LS view: inside view of CMP on levee slope. Needs cleaning and clearing.

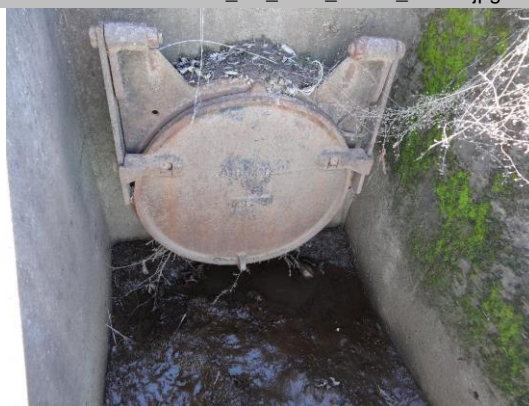
Photo 1 of 2 : UCIP\_SP\_2019\_31964\_58389.jpg

WS view: U type concrete headwall and CMP on levee slope. Vegetation debris and mud in outlet box. Needs cleaning and clearing.

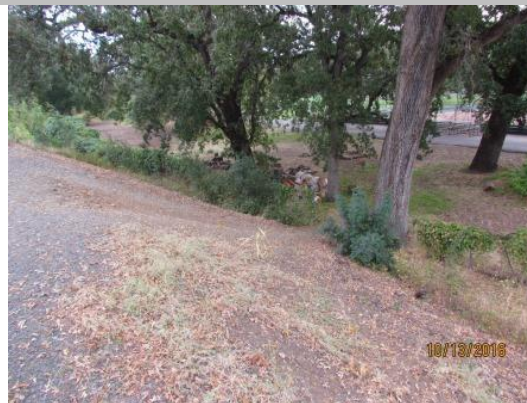
Photo 1 of 1 : SP\_2019\_NA0003\_69\_11\_20190325\_00001.jpg

View of the damaged slope by foot traffic.

| S2 : Repair the levee slope damaged by foot traffic and prevent access where possible. | | | | | |
